AT88SC0204 resetter by GenaAlfa Recommended schematic with PIC18F2550

Schematic with PIC18F4550 is not recommended, but works

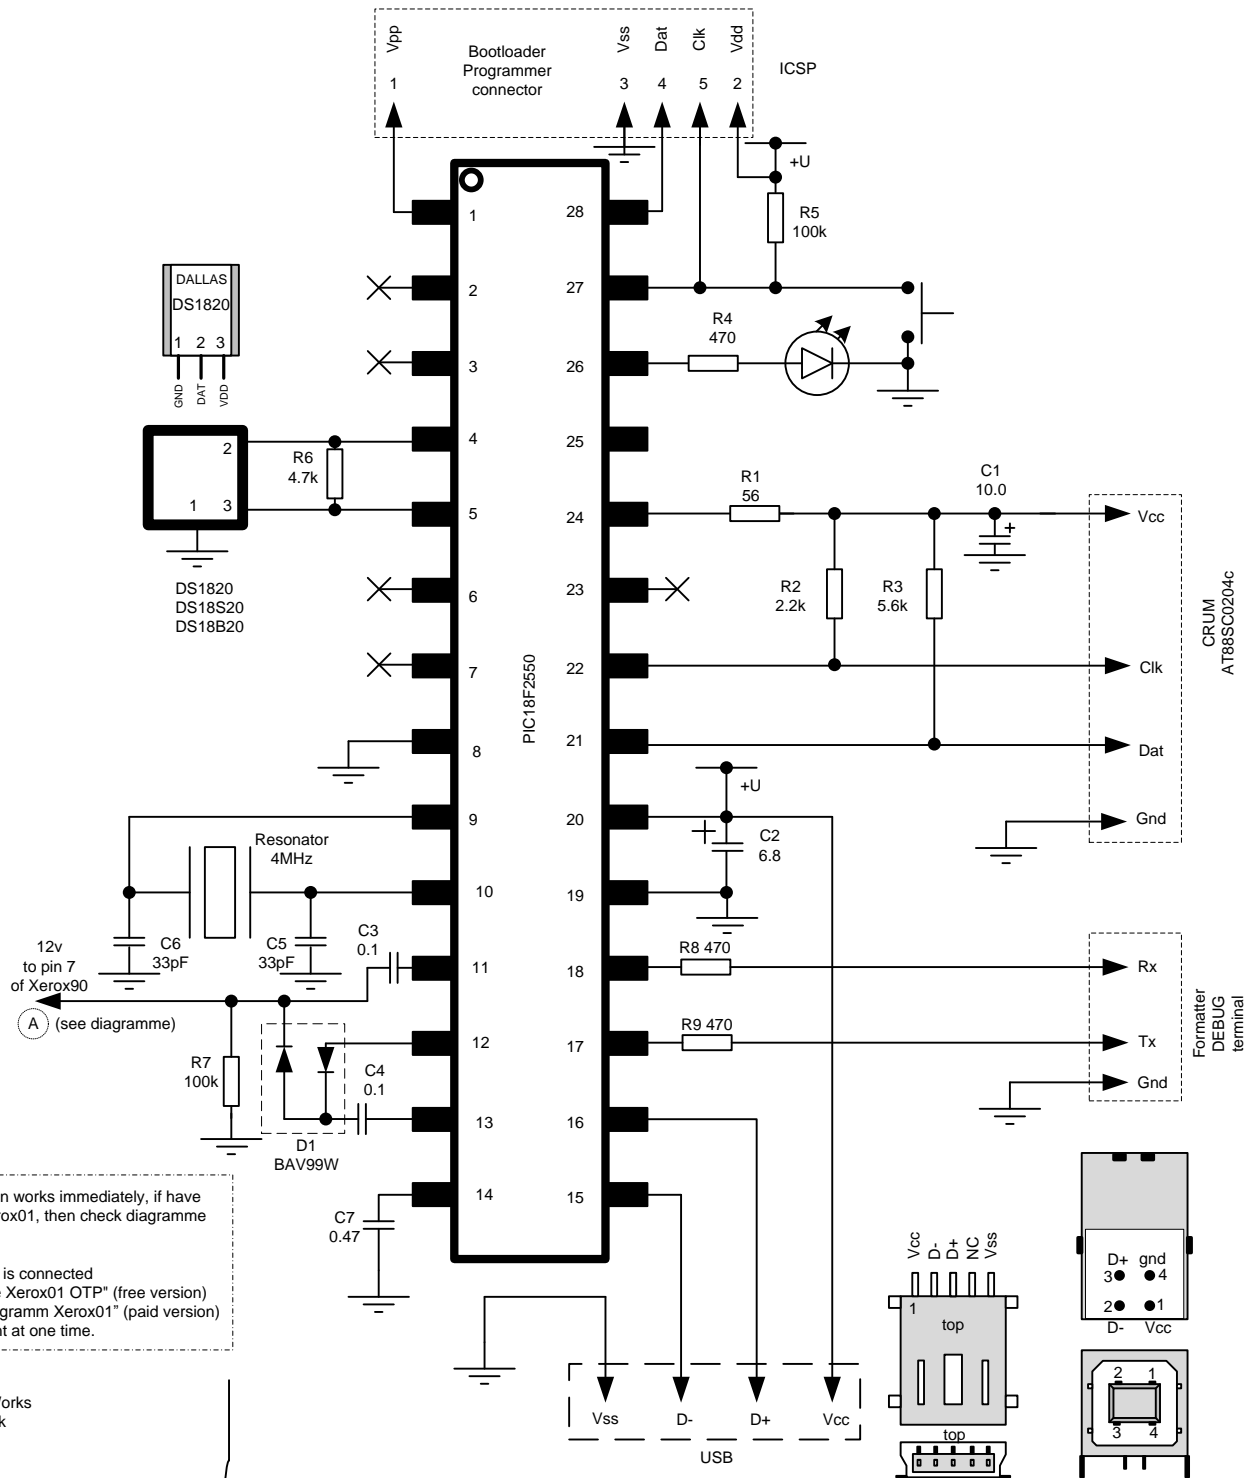
If all components is correct, then works immediately, if have problems with OTP zone of Xerox01, then check diagramme at point A

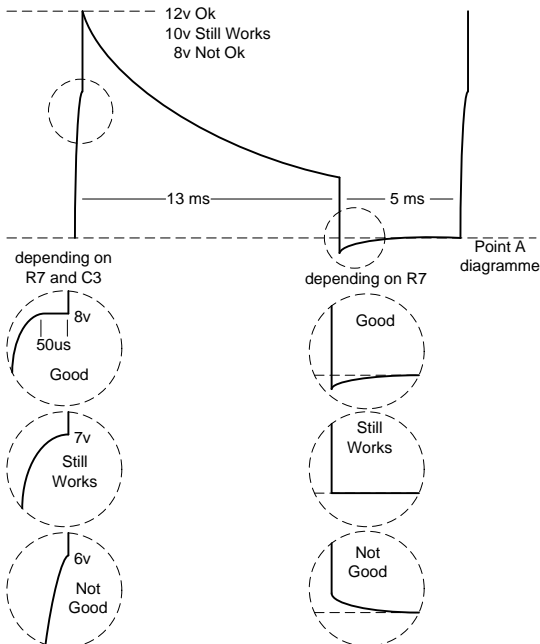
Test Condition:

- 1.Xerox01 chip is connected
- 2.Select "Erase Xerox01 OTP" (free version) or Press "Programm Xerox01" (paid version)

Only 8 impulsess will be present at one time.
